**DEPARTMENT OF TRANSPORTATION**

Contract #: 04-0120F4Cty: SF/ALA Rte: 80 PM: 13.2/13.9File #: 1.28**WELDING INSPECTION REPORT****Resident Engineer:** Casey, William**Address:** 333 Burma Road**City:** Oakland, CA 94607**Report No:** WIR-028267**Date Inspected:** 26-Aug-2012**Project Name:** SAS Superstructure**OSM Arrival Time:** 700**Prime Contractor:** American Bridge/Fluor Enterprises, a JV**OSM Departure Time:** 1530**Contractor:** American Bridge/Fluor Enterprises, a JV**Location:** Job Site**CWI Name:** See below.**CWI Present:** Yes No**Inspected CWI report:** Yes No N/A**Rod Oven in Use:** Yes No N/A**Electrode to specification:** Yes No N/A**Weld Procedures Followed:** Yes No N/A**Qualified Welders:** Yes No N/A**Verified Joint Fit-up:** Yes No N/A**Approved Drawings:** Yes No N/A**Approved WPS:** Yes No N/A**Delayed / Cancelled:** Yes No N/A**Bridge No:** 34-0006**Component:** OBG**Summary of Items Observed:**

OBG 12W (Interior)

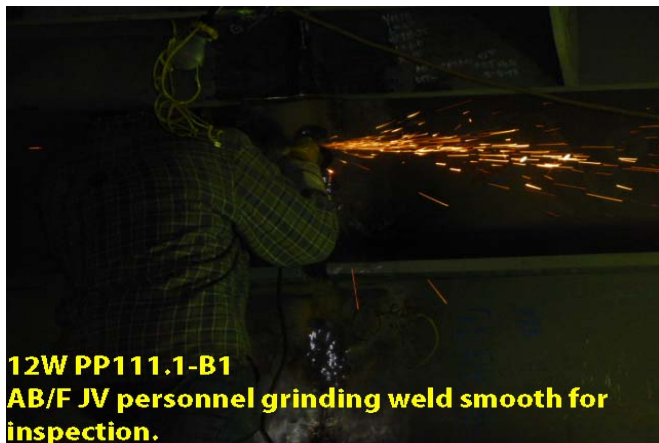
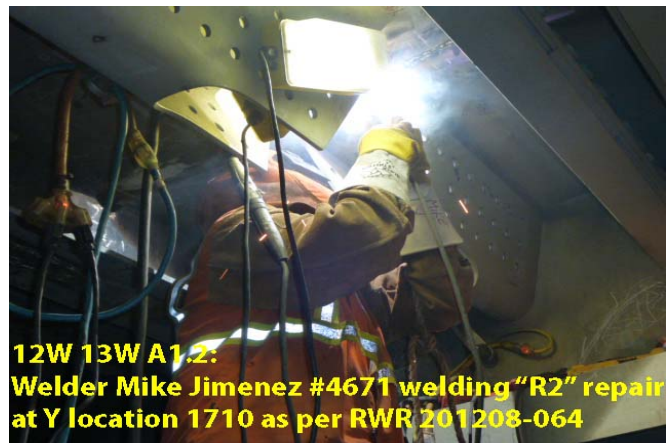
Welder Mike Jimenez was observed performing weld repair on Ultrasonic Testing Shear Wave rejects (UTSW) on weld 12W 13W-A1.2. The "R2" reject noted by shear wave (UTSW) was at Y location 1710. After excavation of the reject it was then Magnetic Particle Tested (MT) by QC Patrick Swain and this QA. No indication was noted in the 60 x 25 x 10 Deep excavated area. The excavation was then weld repaired utilizing Caltrans approved Welding Procedure Specification's (WPS) ABF-WPS-D1.5-1004-Repair as per Request for Weld Repair (RWR) #201208-064.

- Repair "R2" at Y location 1710 (60 x 25 x 10 Deep, MT Accept.)

The above weld was previously accepted by QC Magnetic Particle technicians. This QA observed no rejectable indications at the time of testing. This QA Inspector generated a TL-6028 MT report on this date. The completed work observed at this location appeared to be in compliance with the contract specifications.
